Test Intention:

In test 5006a we want to investigate the lifespan of our CFBUS.052 in a 100mm radius.

Series / No: CFBUS.052 Installation type: horizontal, short way
 Customer test: Yes No Development test: Yes No

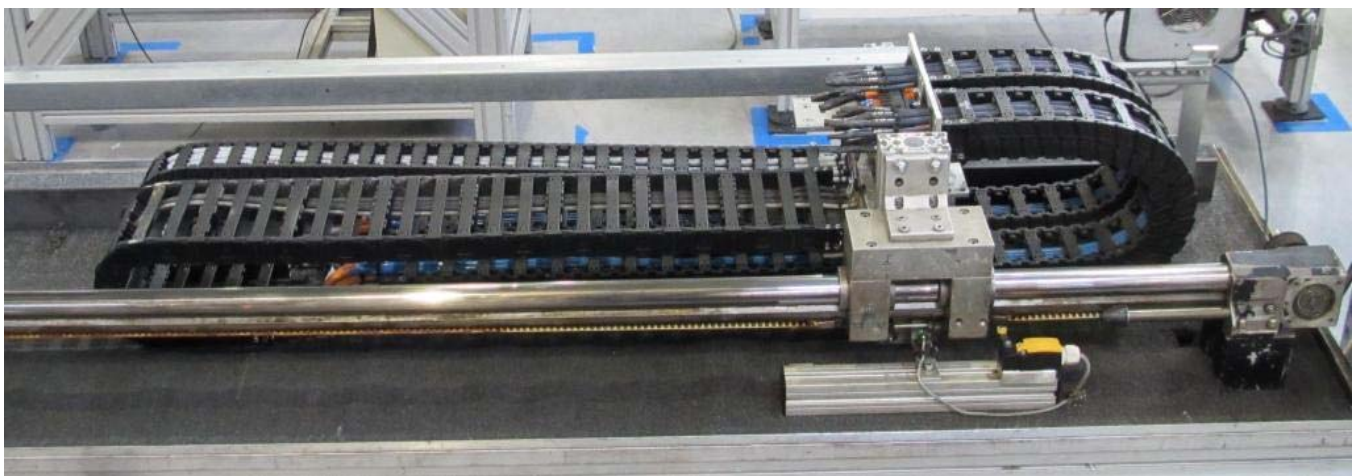
This test is built up on the „Zollern“. The following picture shows the test structure:
